Energy Retrofit Infill Panels for Historic Timber-Framed Buildings in the UK: Physical test panel monitoring versus hygrothermal simulation

Christopher J. Whitman¹, Oriel Prizeman¹, Julie Gwilliam¹, Andy Shea²,
Pete Walker²

As we aim to decarbonise the built environment, care must also be taken to minimise the negative impact of retrofit actions on historic buildings' fabric and cultural significance. Work to date in the UK has focused on the retrofit of historic solid masonry construction, with little research into historic timber-framed buildings. With these buildings, where infill panels are beyond repair or have previously been substituted with inappropriate materials, there exists the potential to retrofit panels with a higher thermal performance. The research presented in this article compares the monitoring of three physical test panels mounted between climate-controlled chambers with digital hygrothermal simulations in order to investigate the risk of increased moisture which may threaten the surrounding historic fabric. Results of previously unpublished cyclical testing are also included. Whilst all prediction methods successfully identified interstitial condensation whe

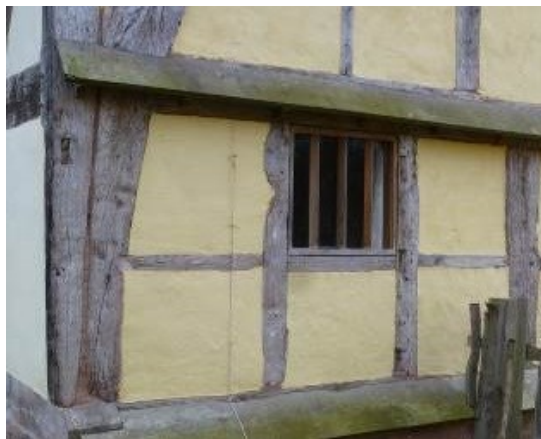
Figure 1. Externally exposed frame.
(Whitman, 2015)

Historic timber-framed buildings in the UK consist of a structural timber frame with a solid infill. This is traditionally wattle-and-daub, a framework of thin timber members (wattlework) covered by an earthen render (daub). Other historic infills include lath and plaster and brick nogging (Harris 2010). Whilst some of these buildings are over-clad with tiles, weatherboarding or continuous plaster, in many cases the timber frame is exposed both internally and externally (Figure 1 & Figure 2).

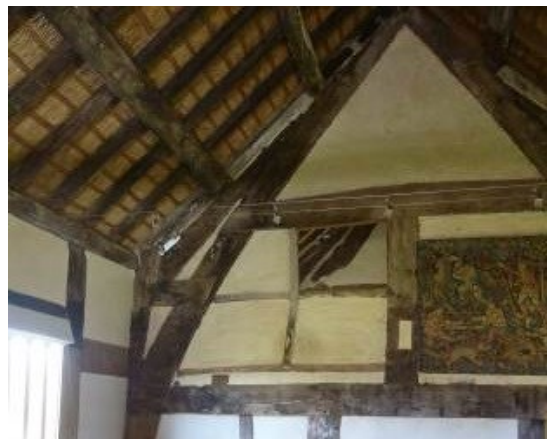
Figure 2. Internally exposed frame.
(Whitman, 2015)

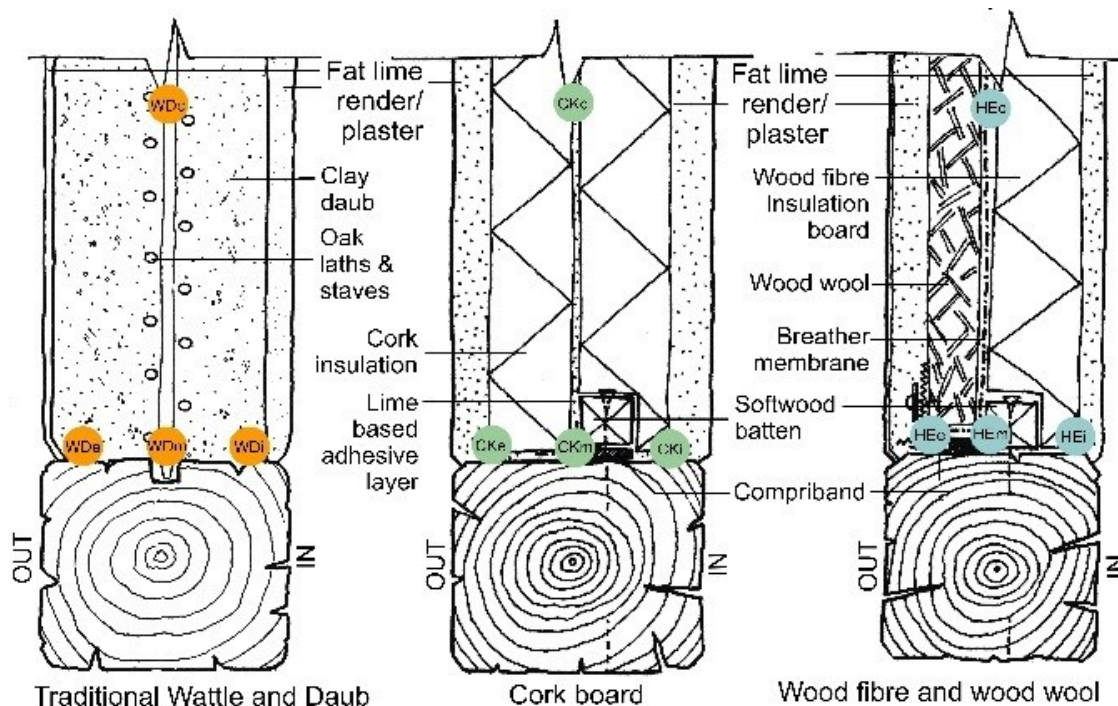
Figure 3. Detailed sections of three panel infill build-ups showing monitoring positions

Considering issues of breathability, built-in moisture content, buildability and environmental impact, a short list of five replacement infill panel solutions were chosen. These were traditional wattle and daub; wood-fibre insulation with lime plaster on woodwool carrier board (McCaig and Ridout 2012); Cork insulation with lime plaster (Ty Mawr Lime Ltd. 2015); hemp-lime (Stanwix and Sparrow 2014); and sheep's wool (Prizeman 2015). Of these the first three were chosen to monitor due to the lack of available material data, required for digital simulation, for the last two infill solutions. Details of the three chosen build-ups are shown in Figure 3.

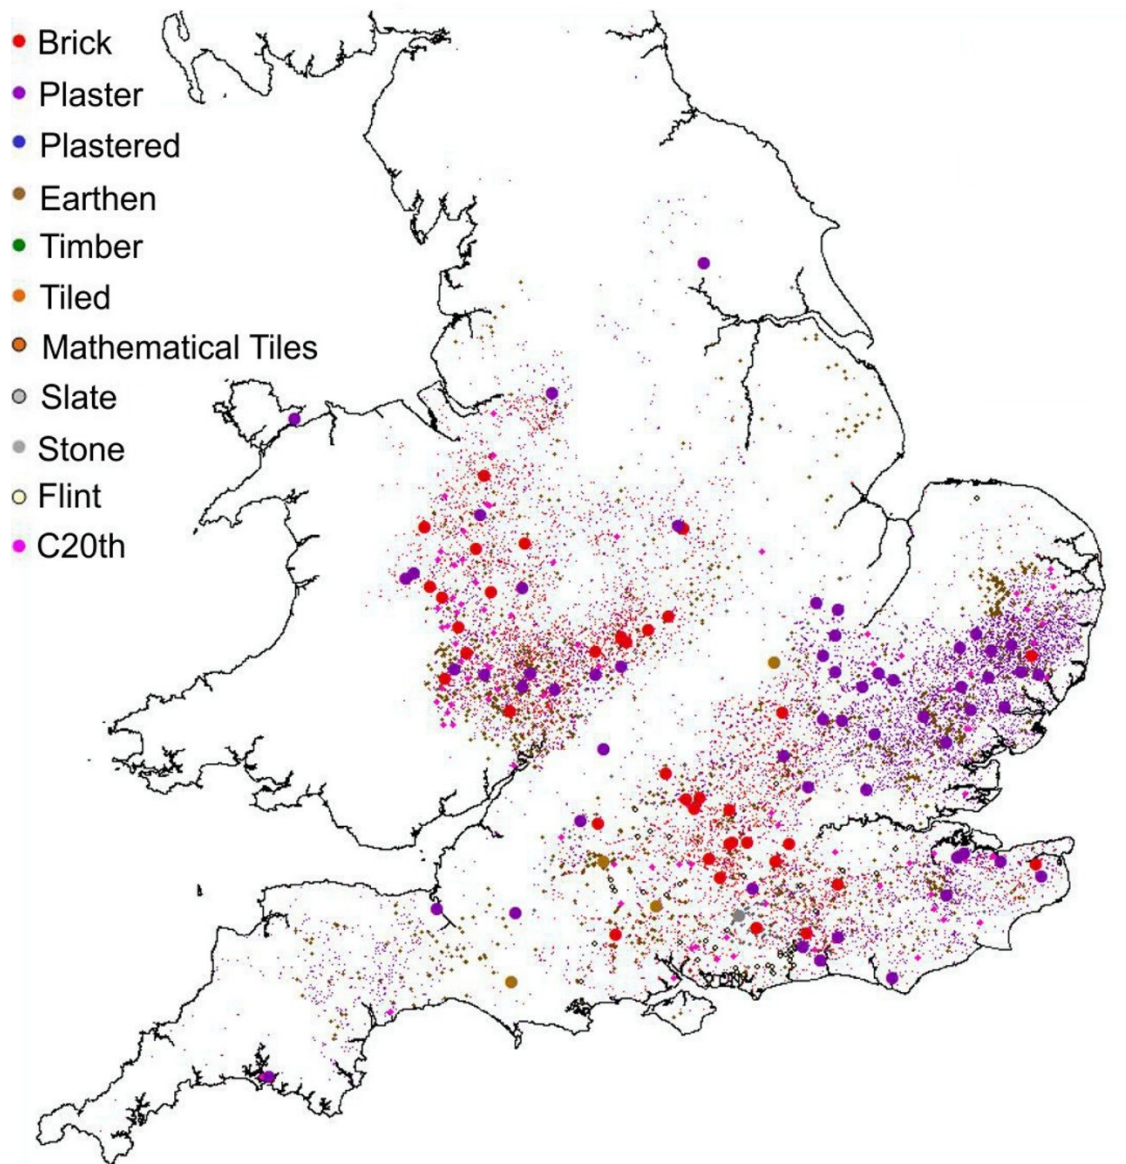
Figure 4. Distribution of timber-framed buildings in England and Wales (small dots) and 100 representative samples (larger dots). Source: Authors' own based on (Historic England 2014; Smith 1988; Suggett 2005; RCAHMW 2014)

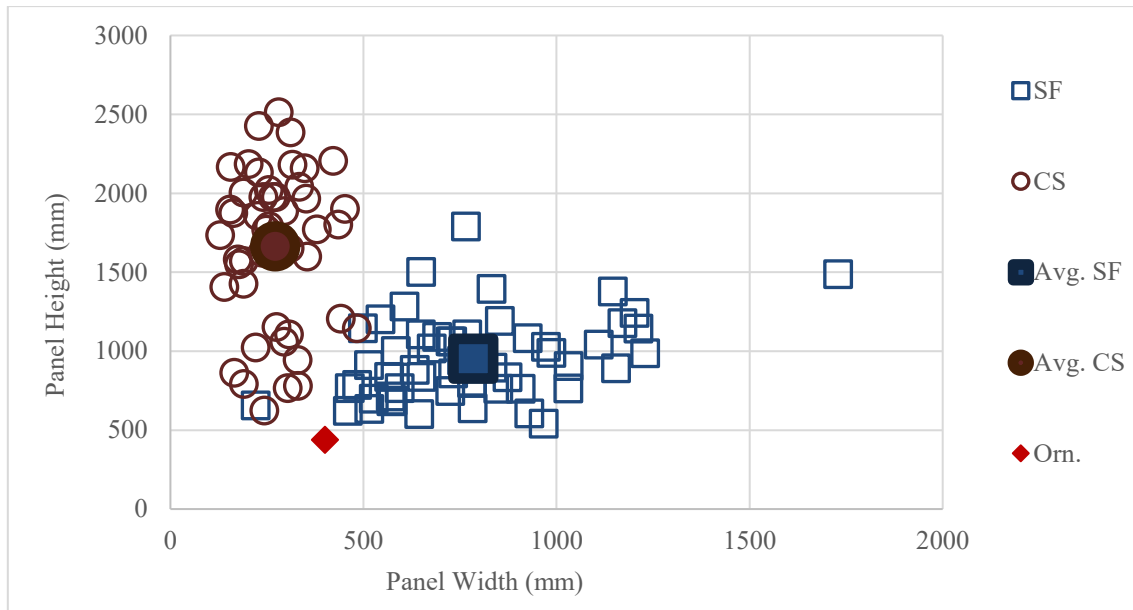
Figure 5. Dimensions of 100 representative sample infill panels. Square Framed (SF), Close Studded (CS), Ornamental (Orn).

A representative sample of 100 buildings was then selected. These proportionally represented the exposed timber-framed buildings with regards to age, building type, panel infill material and geographical location (Figure 4). Using Google StreetviewTM, photos were collected of each of these 100 buildings. These were then scaled and measured in AutoCAD. The measurements were then plotted and the averages taken (Figure 5).

The results indicate that 53% were “square framed”, 46% “close studded” (tall rectangular panels) and 1% “ornamental”. The average dimensions of the square framed panels were 785mm x 950mm (L x W) with a standard deviation of ± 260 mm. As such, the test panels of 820mm x 820mm x 100mm (L x W x D) can be said to be representative in size.

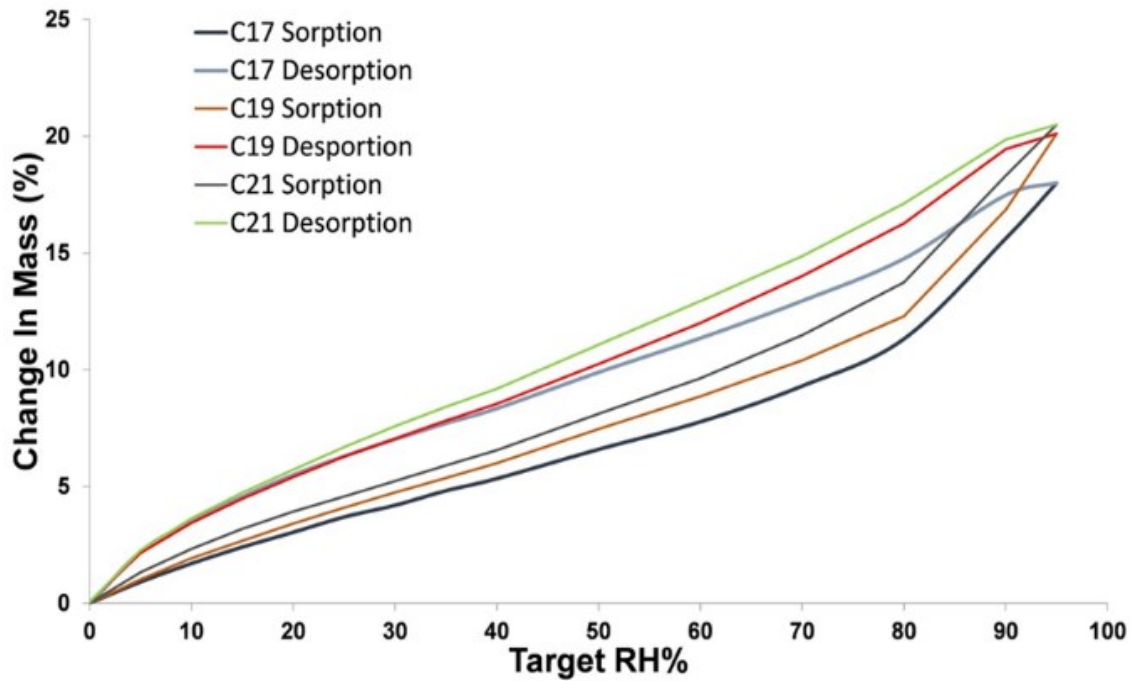
Figure 6. Sorption and desorption isotherms for three samples of oak felled in different centuries.

Dynamic Vapor Sorption (DVS) analysis was undertaken on three 10mm cubes of oak felled in the 17th, 19th and 21st centuries. The analysis was undertaken by Surface Management Systems Ltd using their DVS-Advantage instrument. The samples were initially dried for 600 minutes under a continuous flow of dry air to establish their dry mass. The samples were then exposed to the following typical partial pressure (vapour pressure/ saturation vapour pressure (p/po)) profile: 0% to 40% p/po in 5 % steps, then to 90% p/po in 10% step increments, and then a 5% step to 95% p/po and then decreased in a similar manner (Demonstration & Contract Testing Services 2015). The instrument measured the mass of each sample throughout this process and provided results as percentage change in mass against percentage relative humidity. The results are presented in Figure 6. This shows that the older timber absorbs less moisture overall. It also shows a maximum hysteresis for each sorption curve (absorption against desorption) of 3.7%, 4.0% and 3.4% in order of age. It was therefore concluded that for the test cell historic reclaimed timbers should be sourced as opposed to newly felled.

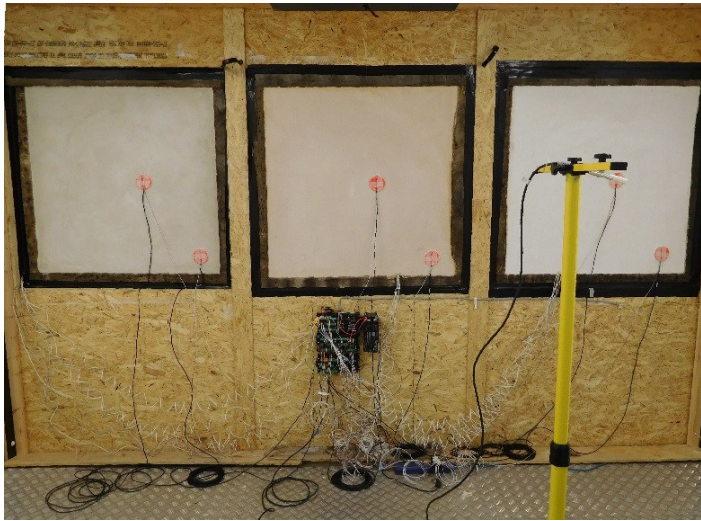
Figure 7. Panels in climate chamber. View from “internal” chamber.

The three panels, each measuring 1120 by 1120 mm, were mounted as part of a dividing wall between the two climate-controlled chambers (Figure 7 & Figure 8).

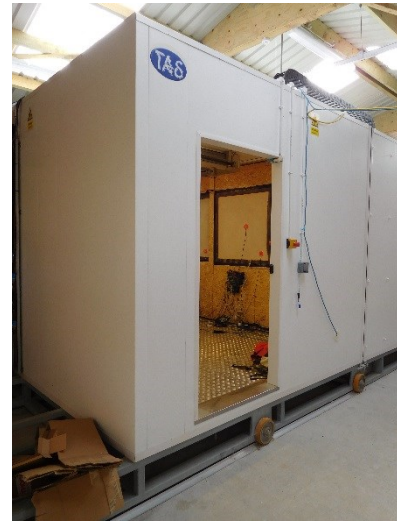
Figure 8. Dual climate chamber

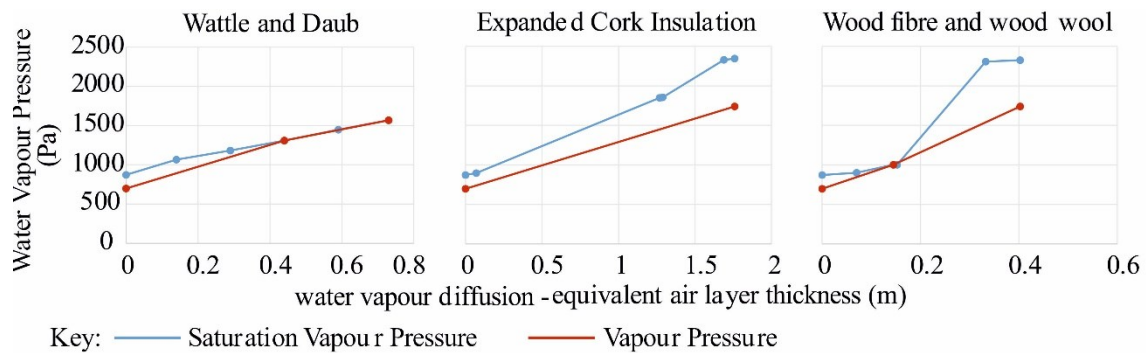
Figure 9. Glazer calculations according to BS EN ISO 13788:2012 for three infill panel constructions with external (left) conditions of 5°C and 80% RH and internal (right) conditions of 21°C and 70% RH. Source: (Author's own, 2017)

For the initial three weeks of monitoring the test panels were subjected to steady state conditions with the aim of forcing increased moisture content. To determine the set temperature and relative humidity of the test chamber, Glaser calculations were undertaken in accordance with BS EN ISO 13788:2012 (British Standards Institution 2012). These calculations plot the vapour pressure against the saturation vapour pressure, across the thickness of the panel build-up under steady-state conditions and constant heat transfer. Where the vapour pressure touches the saturation vapour pressure, interstitial condensation is deemed to occur. The results of these calculations (Figure 9) showed that with internal conditions of $21^{\circ}\text{C}/70\%$ RH and external of

5°C/80% RH, interstitial condensation would occur within the wood fibre panel, and the wattle-and-daub would see an increase in moisture towards its inner face.

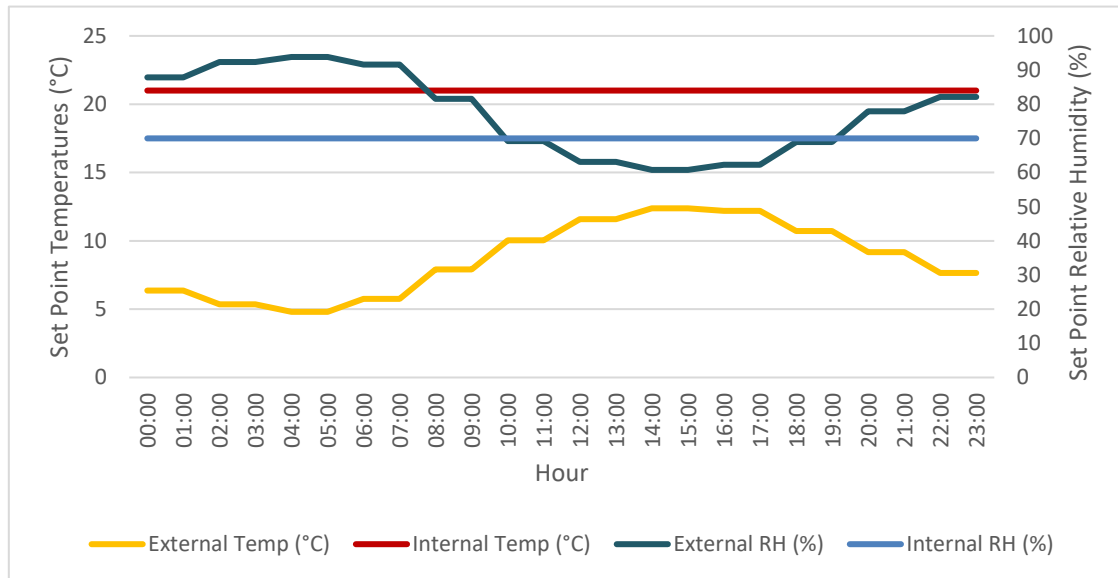
Figure 10. Set points for cyclical conditions for internal and external climate-controlled chambers. twenty-four-hour pattern repeated 14 times over two week period.

for this climate, and the West Midlands due to the location of the majority of case studies in the associated research project (Whitman 2017). As such the climate ranged from 5°C/94% RH to 12°C/61% RH and back over a twenty-four-hour period (Figure 10).

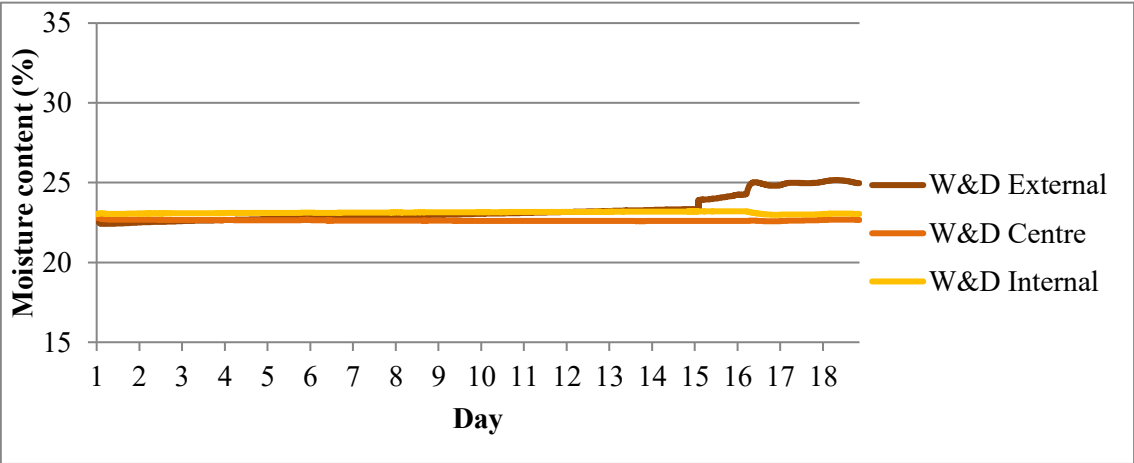
Figure 11. Interstitial moisture content (%) measured in Wattle & Daub (W&D) panel from 14/09/2017 to 02/10/2017 under steady state conditions.

The panel with the most stable moisture content was the wattle & daub (Figure 11), with only a slight increase towards the external edge of the timber frame. This increase was also seen to a far great extent in the other two panels. The only other monitoring position to show an increase was the central location in the woodfibre and woodwool composite panel (Figure 13), confirming the predicted interstitial condensation.

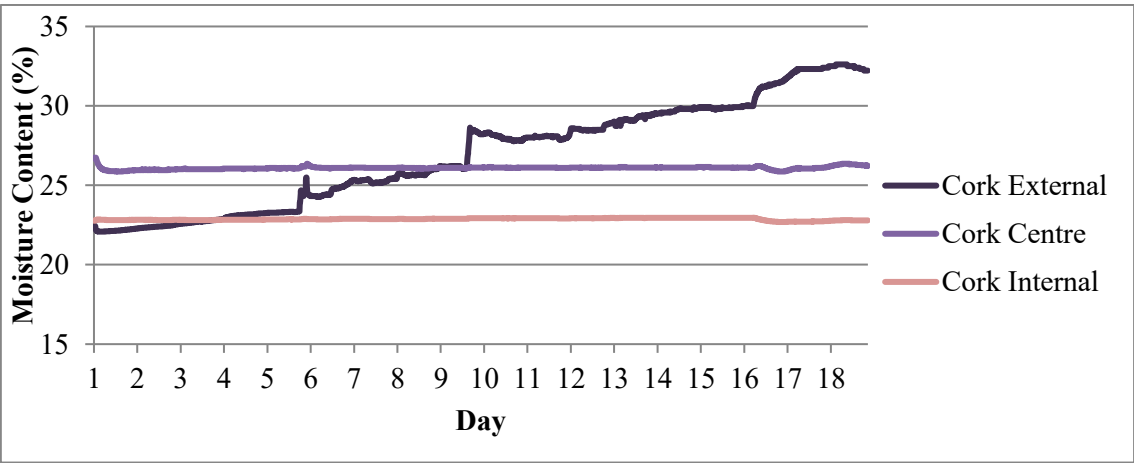
Figure 12. Interstitial moisture content (%) measured in expanded Cork panel from 14/09/2017 to 02/10/2017 under steady state conditions.

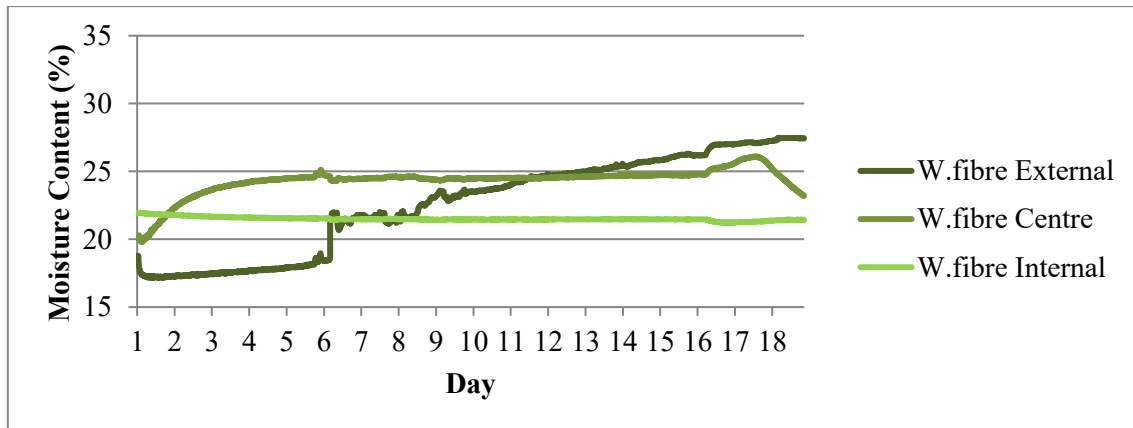
Figure 13. Interstitial moisture content (%) measured in Woodfibre and Woodwool panel from 14/09/2017 to 02/10/2017 under steady state conditions.

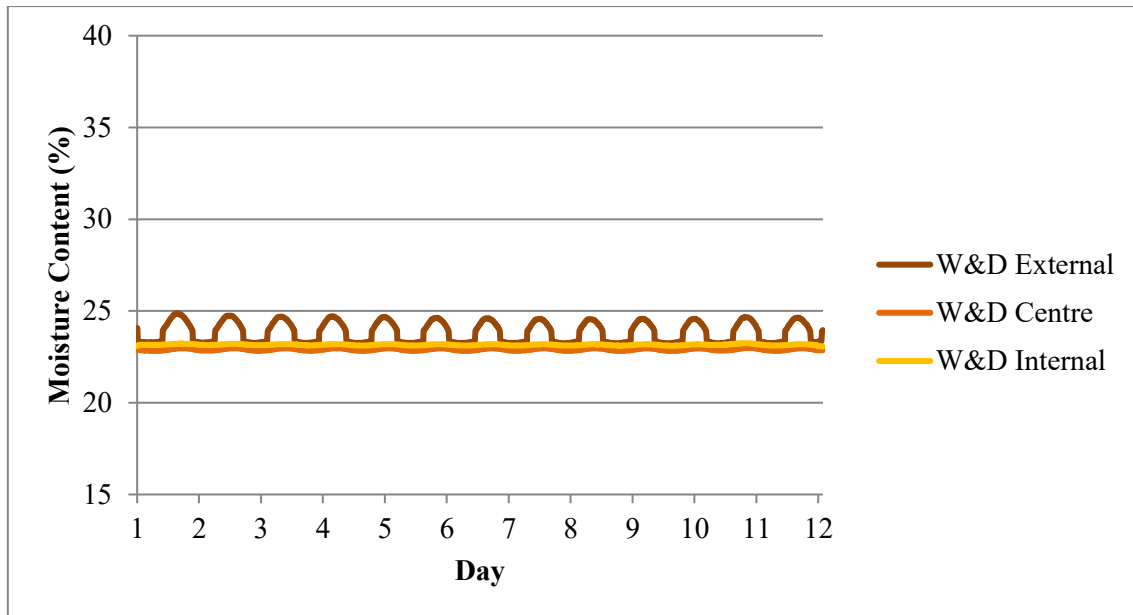
Figure 14. Interstitial moisture content (%) measured in Wattle & Daub (W&D) panel from 02/10/2017 to 13/10/2017 under dynamic conditions.

Most of the monitoring positions show stable conditions, with only minor diurnal fluctuations, most noticeable in the external location. However, in the case of the monitoring position towards the external edge of the woodfibre panel, there was recorded a sharp increase, starting approximately halfway through the monitoring period.

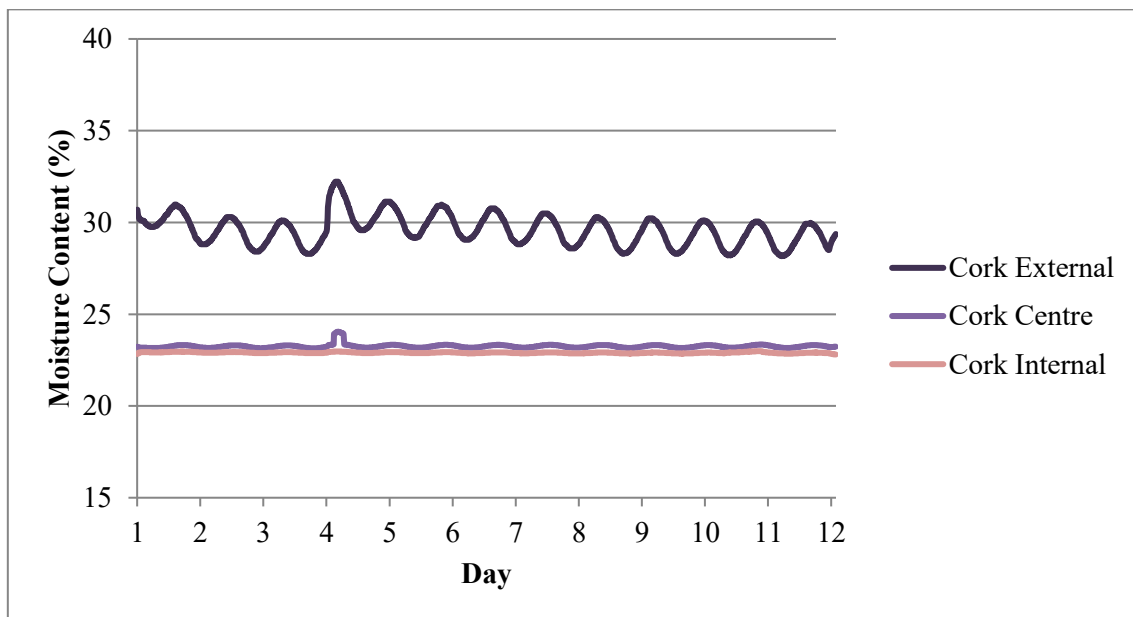
Figure 15. Interstitial moisture content (%) measured in Cork panel from 02/10/2017 to 13/10/2017 under dynamic conditions.

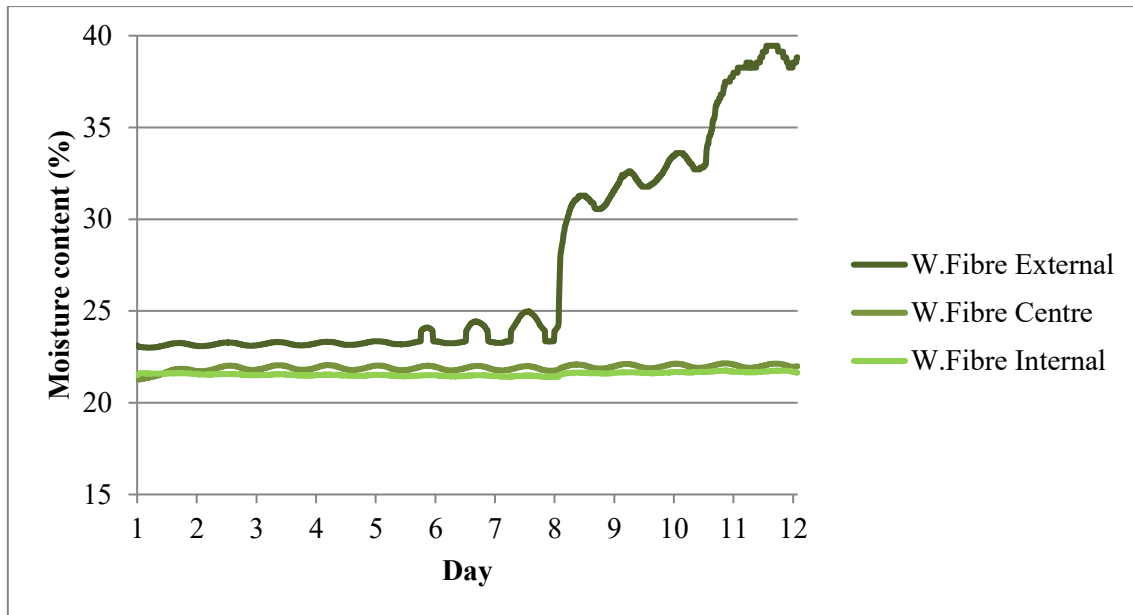
Figure 16. Interstitial moisture content (%) measured in Woodfibre and Woodwool panel from 02/10/2017 to 13/10/2017 under dynamic conditions.
